Manhole Inspection Summary

Manhole # S33Q__007MH

Insp Date: **2/5/08 12:01 PM**

Location Address: **s.howard st**

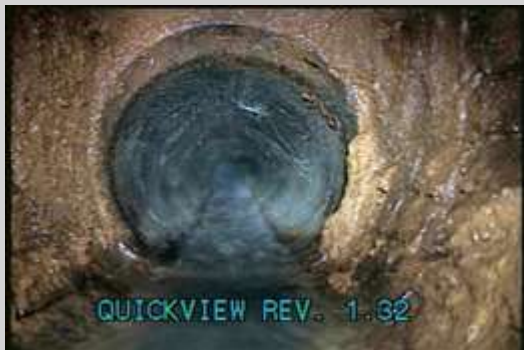
12 O'Clock Outflow

12 in. Circular Gravity Sewer
Pipe Out @ 12 O'Clock

Pipe Material: **Clay** ☐ Pipe Lined

Invert Depth: **18.90** (ft.) Flow Characteristics: **Fast**

Deposits: ☒ None ☐ Mud ☐ Sludge ☐ Debris ☐ Grease

Infiltration: **None** Pipe Seal Cond: **Unknown**

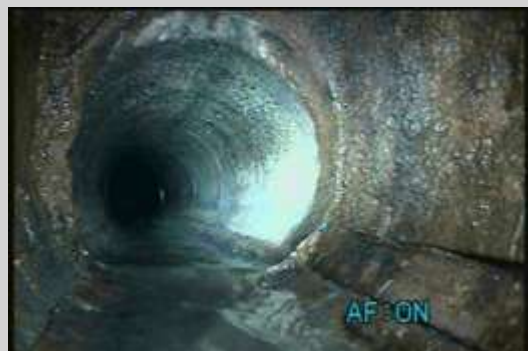
6 O'Clock Inflow

12 in. Circular Gravity Sewer
Pipe In @ 6 O'Clock

Pipe Material: **Clay** ☐ Pipe Lined

Infiltration: **None** Pipe Seal Cond: **Unknown**
